NATIONAL PROGRAM FOR INSPECTION OF NON-FEDERAL DAMS
NICHOLS POND DAM (VT.) (U) CORPS OF ENGINEERS WALTHAM MA
NEW ENGLAND DIV APR 80

Nichols Pond Dam VT00184

APR 1980

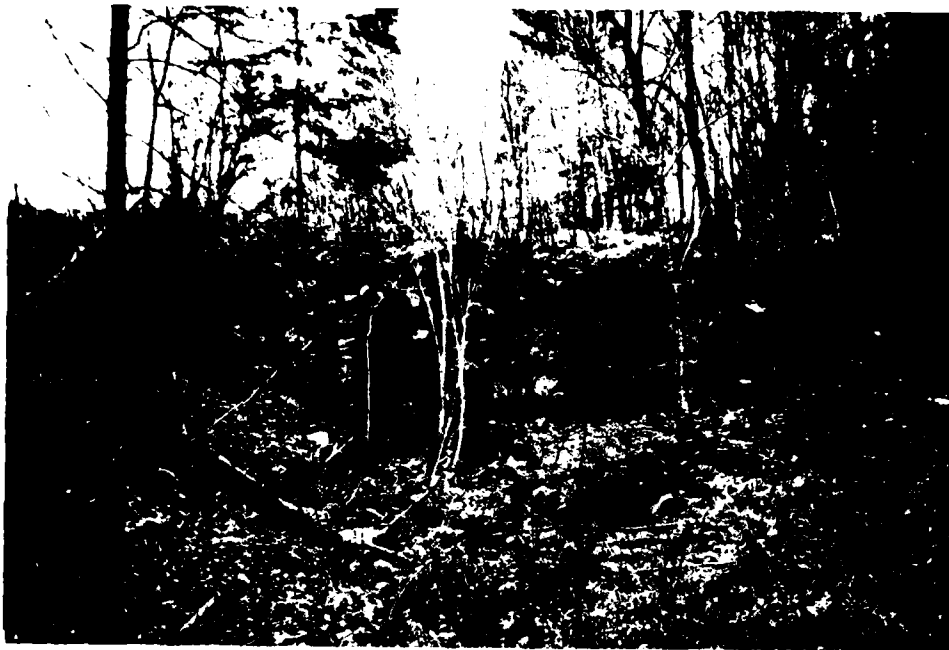
b. Dam. The dam consists of an earthen embankment with a dry masonry downstream face (photo 1) and a concrete upstream face (photo 2). The upstream face of the dam is a vertical concrete wall (photo 3). A new wall has been built immediately upstream of the original wall. The exposed part of the new wall appears in good condition with only minor spalling and cracking, while the old wall shows severe spalling in its exposed upper part (photo 4). The old wall appears to have settled slightly, on the right side of the spillway. The new wall does not show evidence of settlement.

1. Downstream face of left side of dam

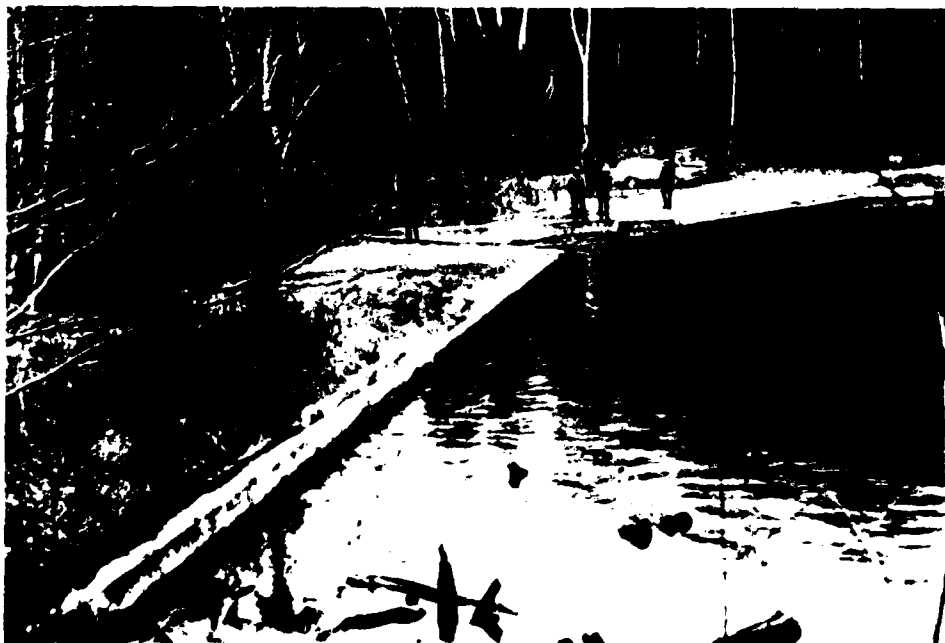
2. Upstream view of dam from left

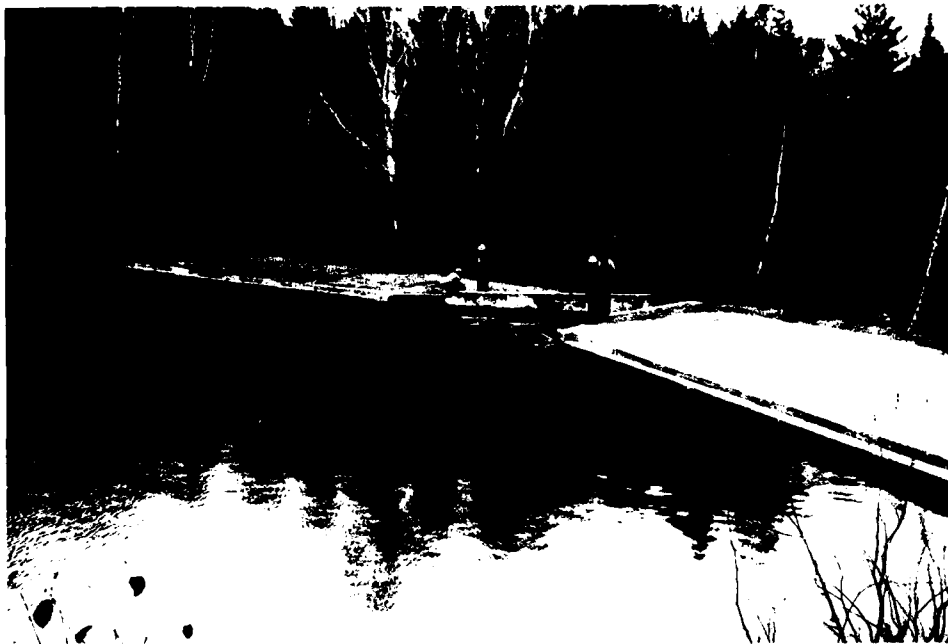
3. Upstream view of dam from right abutment

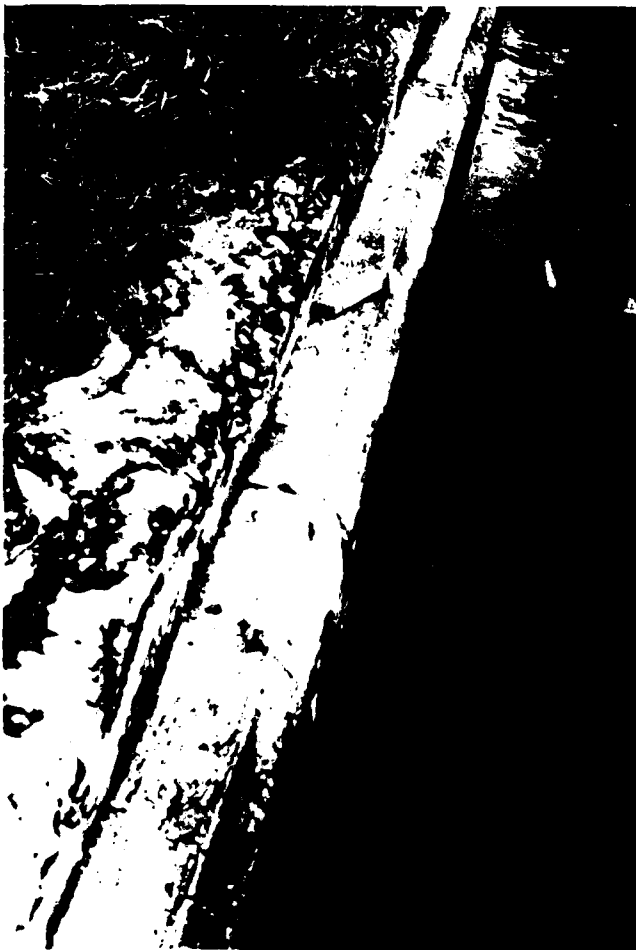
4. Close-up of upstream concrete wall.

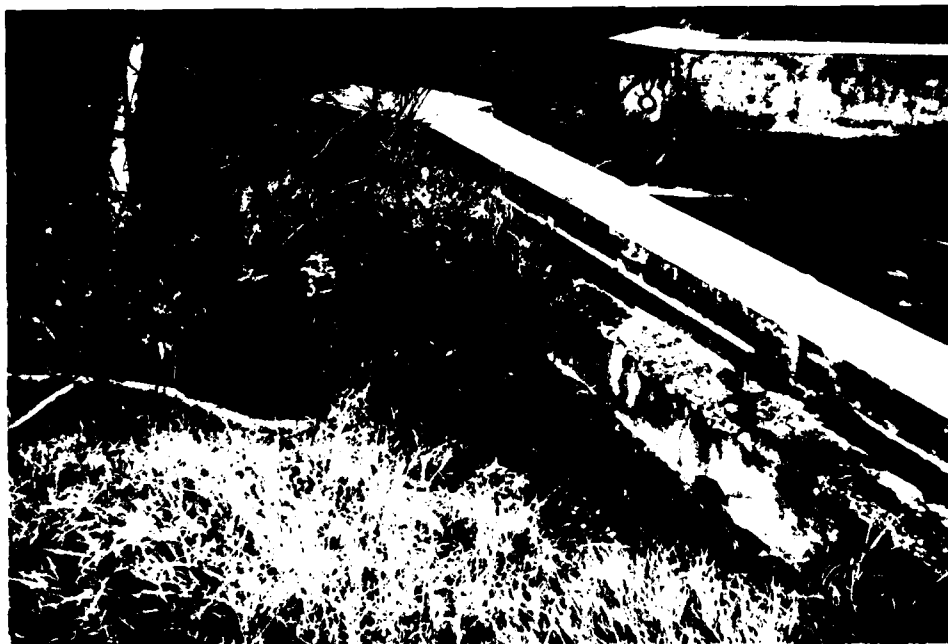
- b. A cavity produced by erosion of earth fill against the left spillway wall, if enlarged, can result in damage to the spillway floor and left wall which in turn could cause flow into the cavity and further erosion. Enlarging of the cavity will develop rapidly in case of overtopping of the dam.

- e. The scour or spalling of the spillway walls may indicate a serious problem with the original design of the spillway. The unusual throat configuration at the downstream end of the spillway may become the hydraulic control, thereby forcing a hydraulic jump in the middle of the spillway. The resulting roller could be the origination of the scour to the left of the spillway as shown in photo 6.

6. Cavity to the left of spillway

1. Remove trees and bushes growing on the crest and overhanging the downstream channel.
2. Fill the cavity next to the spillway left wall with lean concrete or compacted clayey soil.
3. Repair cracked and spalled concrete on the principal spillway.
4. Restrict trespassing from the crest of the structure.
5. Establish a program of annual technical inspections by a registered qualified engineer.
6. Develop a formal surveillance and downstream flood warning plan including round-the-clock monitoring during heavy precipitation.
